**Interlude Condominiums**  
**70 Gallun Lane**  
**Snowmass Village, CO 81615**

**Level 2, Premium Reserve Analysis**

**Report Period – 01/01/15 – 12/31/15**

**Date of Property Observation - April 29, 2015**  
**Project Manager - Eric Vogt, CMCA, AMS**  
**Main Contact Person - Ms. Jami Downs, Community Manager**  
**Report was prepared on - Thursday, July 02, 2015**

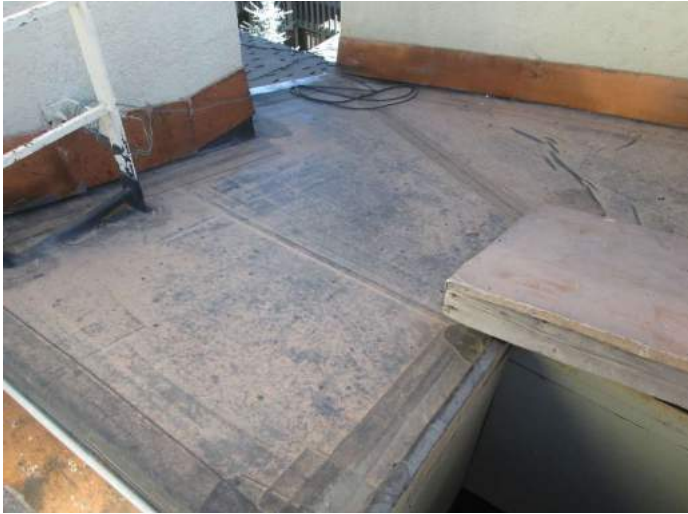
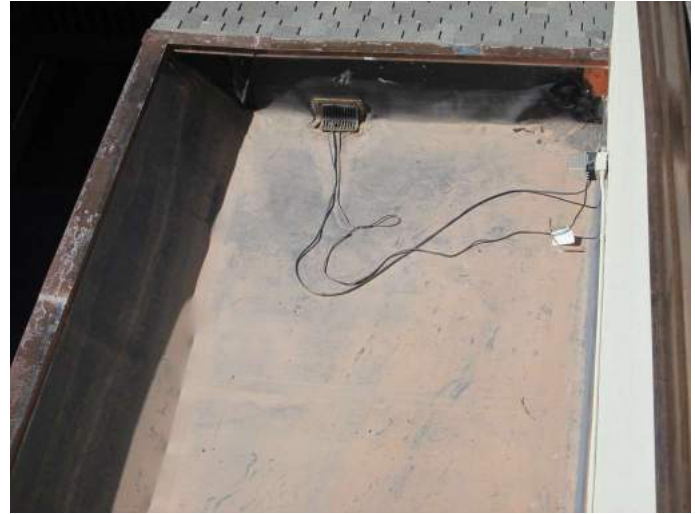
Comp #: 103 EPDM Flat Roof - Replace

- The EPDM roofs appeared to be in fair condition at time of observation with no unusual conditions noted. There were a few areas noted where the roof was no longer adhered to the substrate (to be expected at this age).
- EPDM roofs in this environment typically last, on average, 20 years before micro-holes and failing seams present.
- With the relatively simple EPDM roof areas, the low traffic reported, and separation from the asphalt shingled roof areas, we recommend that funding be provided to replace these roofs independent of the other roofs.

**Best Cost:** \$9,600  
\$1,200/square; Estimate to replace

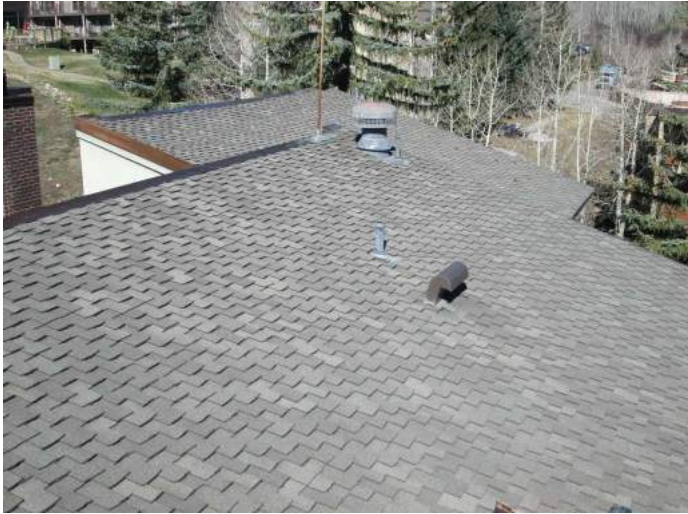
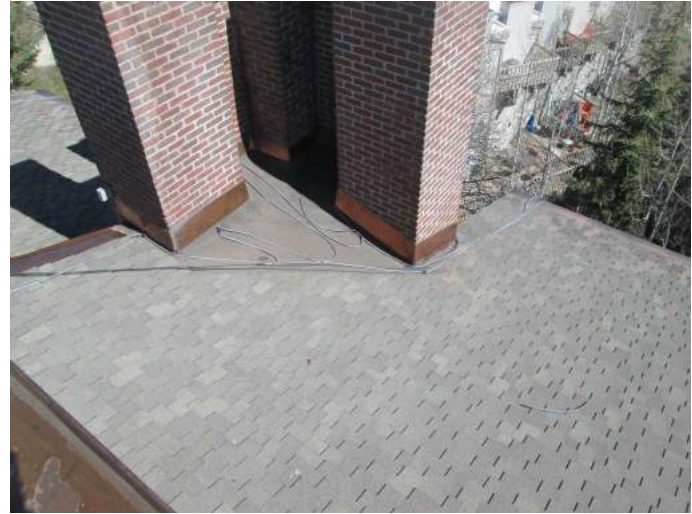
Comp #: 105 Asphalt Shingle Roof - Replace

- The triple layer asphalt shingle roof appeared to be in good to fair condition with little surface deterioration, cupping, or cracking noted throughout. The modified bitumen roofs near the chimneys showed the most weathering.
- Roofs in this climate, with frequent freeze/thaw cycles, high UV exposure, and snow/ice build-up, typically have a useful life of approximately 25 years before damage to the underlayment occurs, necessitating replacement.
- Roof inspections should occur annually with needed repairs being performed with operating funds.

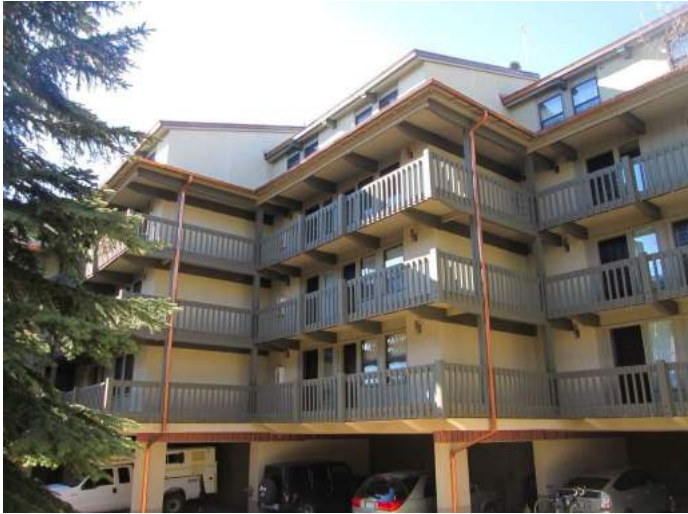
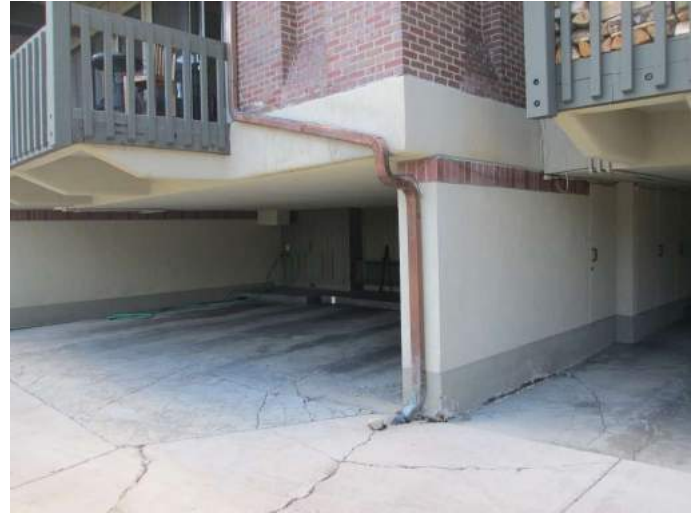
Comp #: 120 Gutters & Downspouts - Replace

- The gutters and downspouts, generally, appeared to be in good condition at time of observation. The only damage noted was at ground level where damage typically occur due to snow and ice removal.
- we typically recommend that gutters & downspouts are replaced when the roofs are replaced.
- Due to the relatively high costs, durability, and age of this material, we recommend that an allowance be provided to replace 25% of this asset (approx. 425 LF) every time the roofs are replaced.

Best Cost: \$10,625  
\$25/LF; Allowance to replace 25% of asset

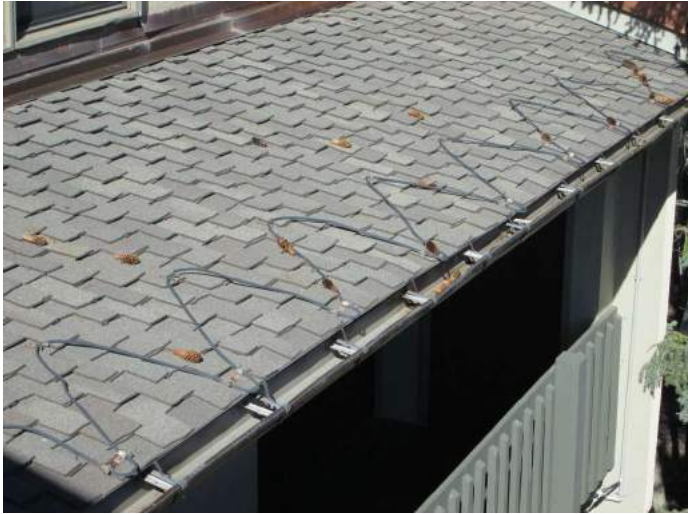
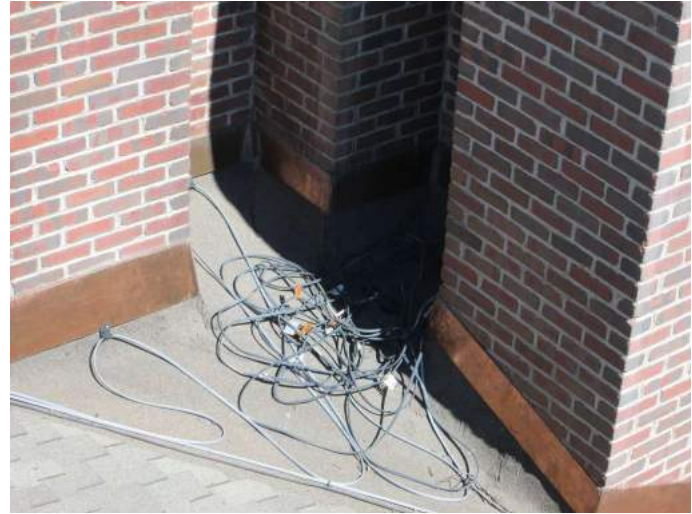
Comp #: 121 Heat Tape - Replace

- In general, the heat tape appeared to be in fair condition with new, protected, tape on eaves and older, failing, tape noted in the chimney areas. It was reported that approx. 30% of the tape has failed or is failing.

- As tape with higher demands/exposures will have a shorter useful life (6 - 10 years) than tape in protected areas, like eave panels, (18 - 22 years) we recommend that an allowance be provided to replace 33% of tape every 8 years.

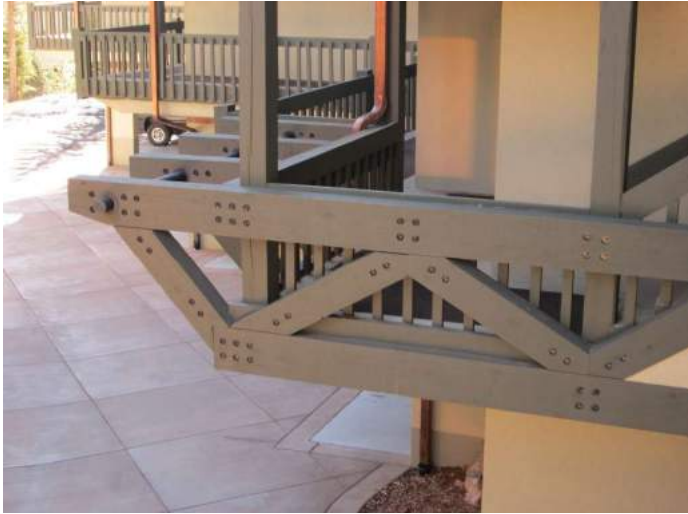
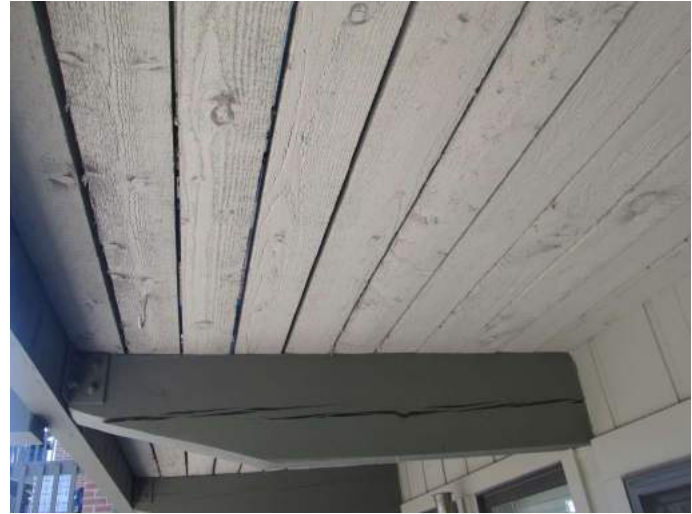
Comp #: 204 Exterior Wood Surfaces - Repaint

- The exterior wood surfaces conditions varied from fair to poor, during observation, with fading, peeling paint and exposed wood noted on a majority of southern aspects and those areas with higher exposures to weather.
- In this environment, it is recommended that these surfaces are painted every 4 - 6 years to protect them from advanced deterioration and to provide a first class appearance.
- Prep, including pressure washing, scraping, board replacement and priming should be included in the scope.

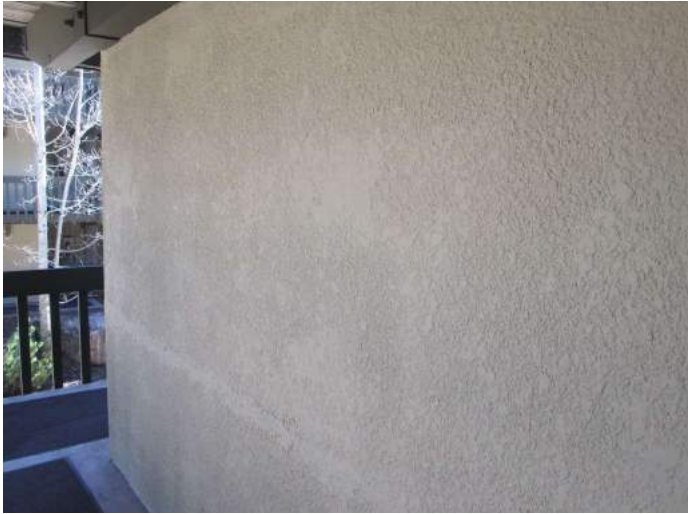
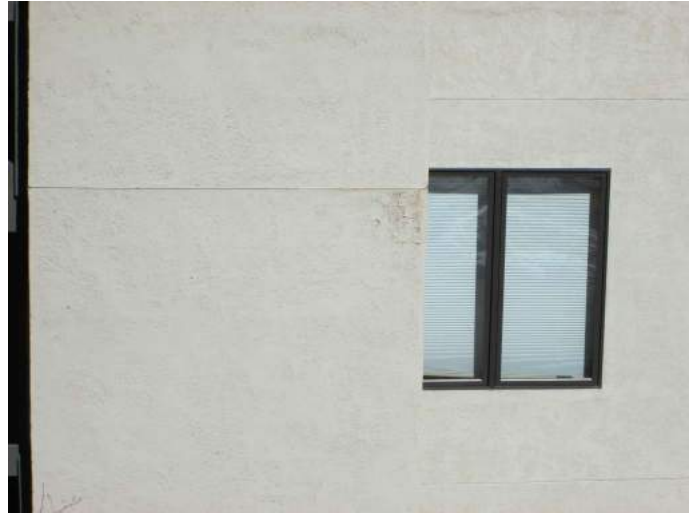
Comp #: 205 Exterior Stucco Surfaces - Repaint

- The exterior stucco surfaces were, generally, in fair condition at time of observation.
- It is recommended that funding be provided to repaint these surfaces, with a product specifically designed for this finish, every 10 - 12 years to ensure a uniform appearance and protect the surfaces from accelerated deterioration.
- This work has been aligned with other painting projects to ensure the best possible cost estimates.

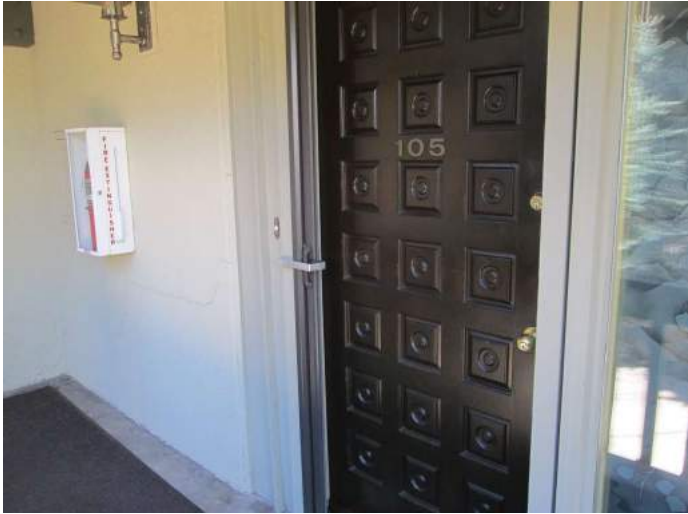
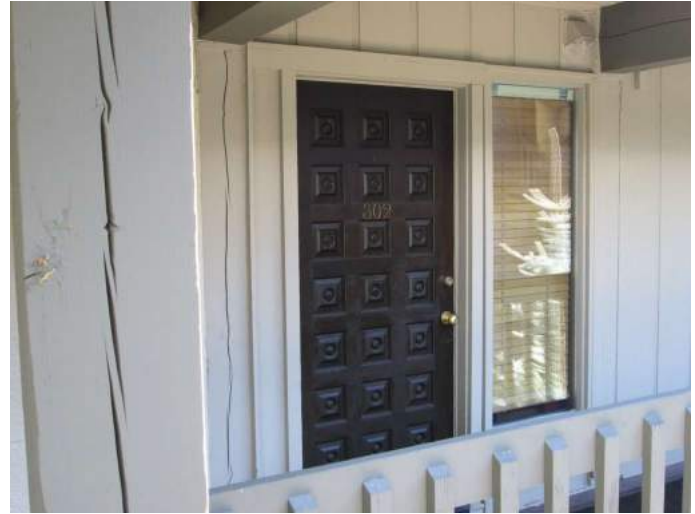
Comp #: 219 Exterior Unit Doors - Refinish/Repaint

- The unit doors appeared to be in fair condition, during inspection, with normal wear and tear noted during observation. There was no advanced deterioration noted on any of the doors.
- Outside of annual touch-ups to protect the finish on these doors, we recommend that they are refinished every 10 years (every other painting cycle) to ensure a uniform appearance and pleasing arrival experience.

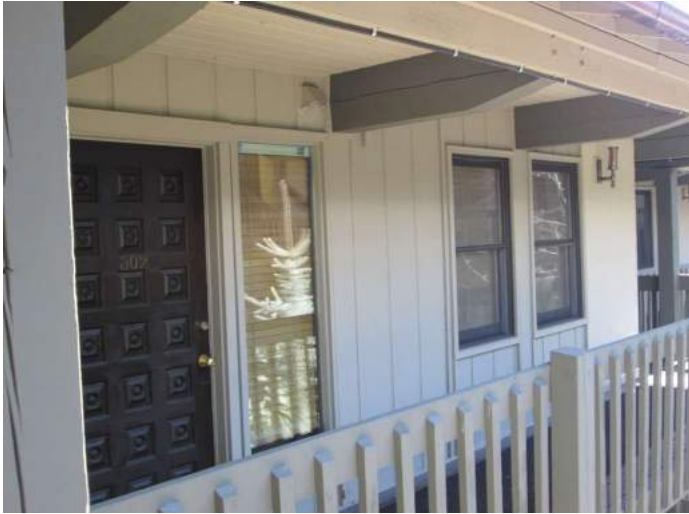
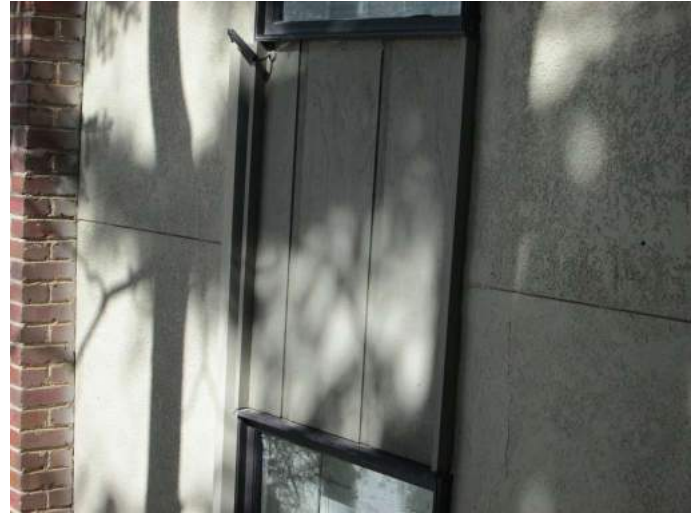
Comp #: 303 Exterior Wood Surfaces - Major Repairs

- The natural wood exterior surfaces throughout the property appeared to be in good to fair condition with only a few areas showing advanced deterioration and needing attention.
- It is recommended that an allowance be provided to perform repairs the exterior wood surfaces experiencing advanced deterioration, and the cause of the deterioration (if possible), every other painting cycle.
- This work has been aligned with other exterior building projects for best possible cost estimates.

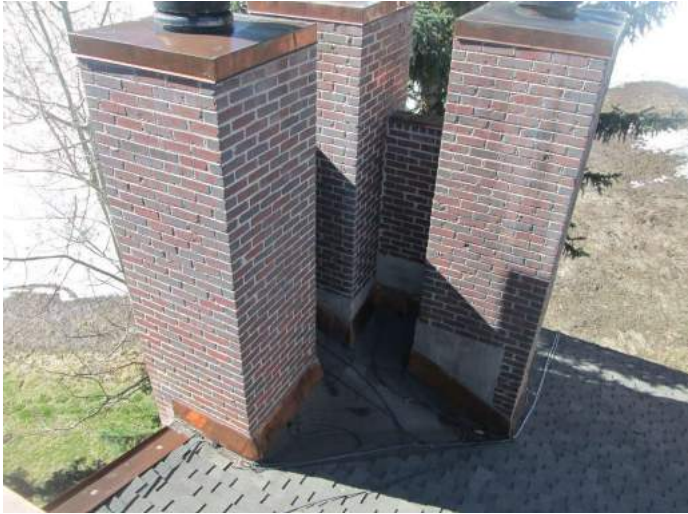
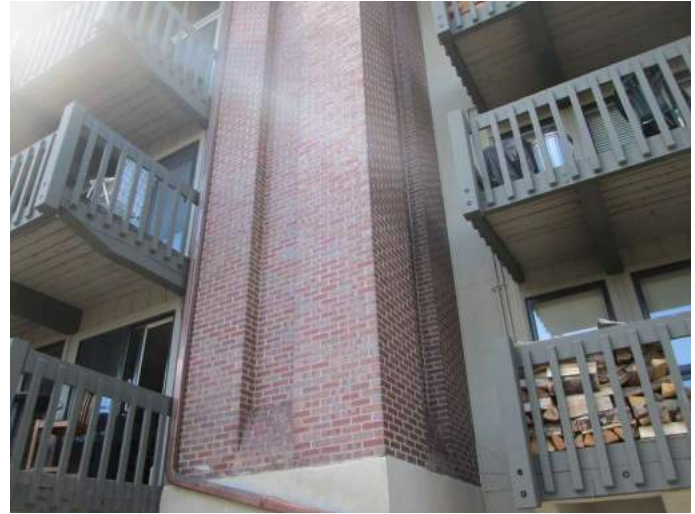
Comp #: 306 Exterior Brick Surfaces - Replace

- Considering the age of the property, the brick surfaces appeared to be in good condition, during observation, with no loose or missing stones or grout noted.
- With proper annual maintenance, it is unlikely that widespread failure of these exterior surfaces will occur. As such, burdening membership with this expense isn't recommended at this point in time.
- If widespread failure begins to present, future updates can included funding for the repair of these surfaces.

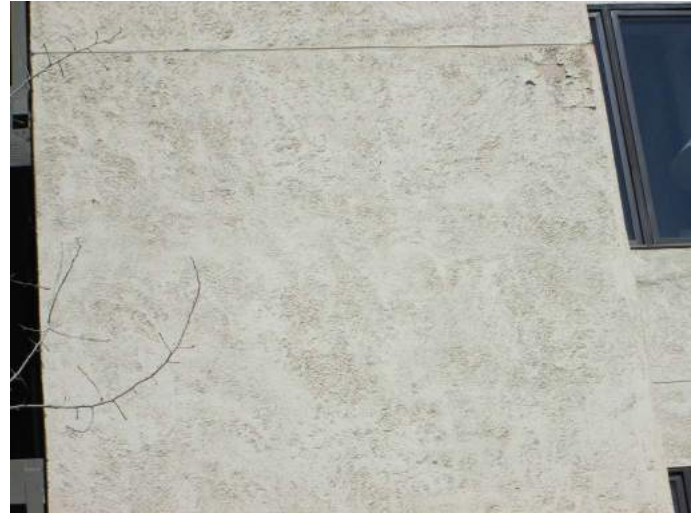
Comp #: 308 Exterior Stucco Surfaces - Major Repairs

- Generally, the stucco surfaces appeared to be in good to fair condition at time of observation with a few areas noted that need to be repaired due to peeling, cracking and delamination.
- In addition to regular painting of the stucco surfaces, it's recommended that that all openings are regularly repaired to protect the substrate and help prevent further deterioration.
- This work should be completed prior to the stucco painting cycle recommended in component 205.

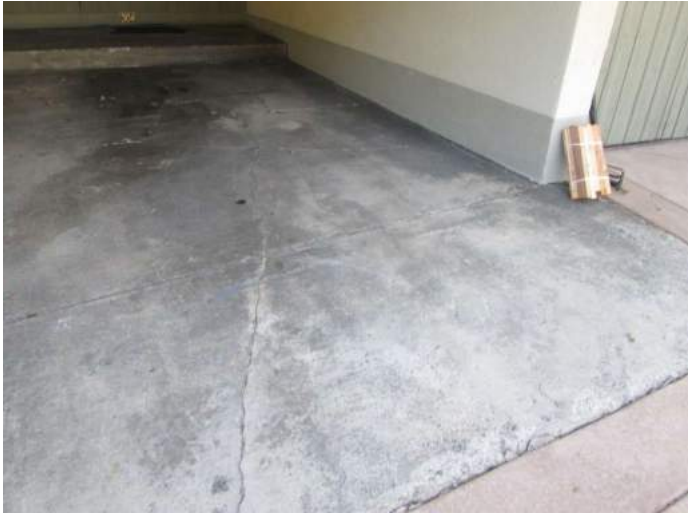
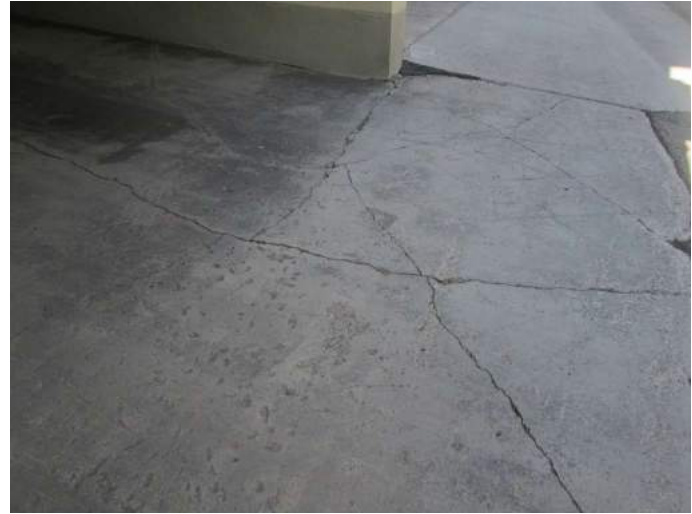
Comp #: 403 Drive Concrete - Repair/Replace

- The concrete drive surfaces were in fair to poor condition, generally, during observation with cracking prevalent.
- As widespread failure of these surfaces is not anticipated, we recommend providing an allowance to replace 20% of the drive concrete (approx. 1,320 GSF) every 6 years.
- As the concrete is more frequently replaced, to make up for prior deferred maintenance, the quantity of replaced concrete can be reduced so as not to overburden membership with excessive replacement.

\$12/GSF; Allowance for repair and replacement

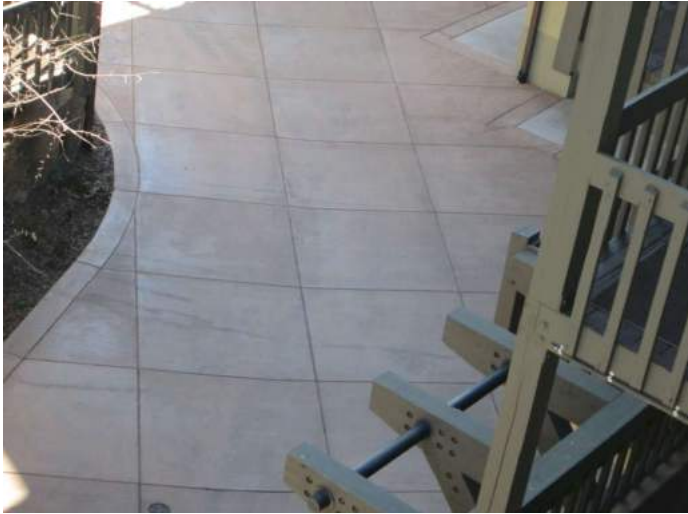
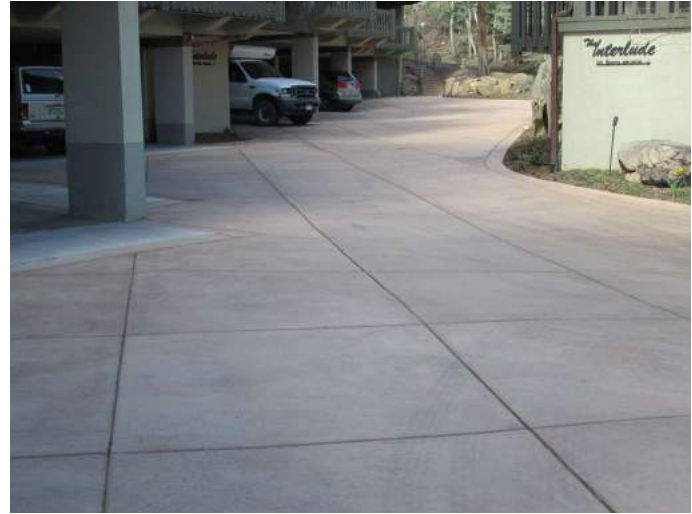
Comp #: 403 Heated Drive Concrete - Repair/Replace

- The heated concrete driveway appeared to be in good condition at time of observation.
- If properly heated during winter months, and assuming that the substrate and drainage were properly addressed during installation, there is little chance that this asset will ever need replacement or major repairs.
- As there is always a chance for boiler failure, or unanticipated damage or settling, it is recommended that funding is provided to repair/replace 20% of these surfaces every 18 years (or every third concrete replacement cycle).

\$15/GSF; Estimate to replace 20% of concrete

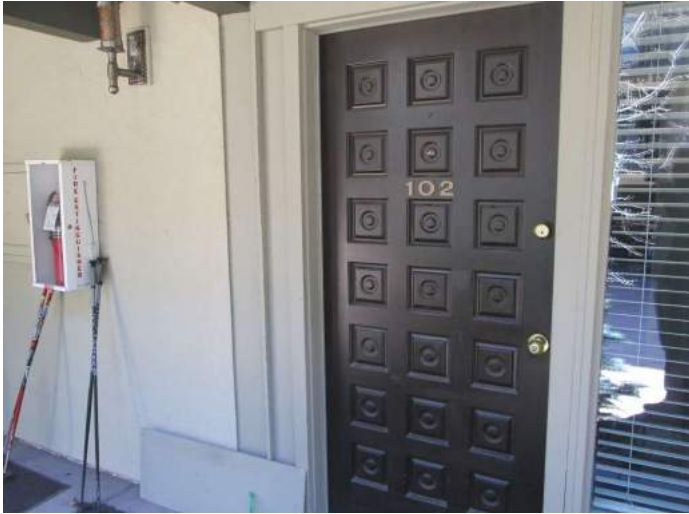
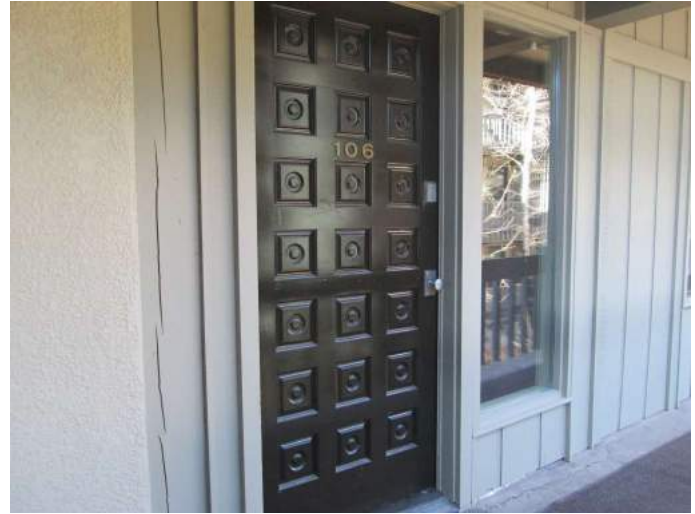
Comp #: 501 Unit Doors - Replace

- during observation, the doors, generally, appeared to be in good to fair condition with no advanced deterioration noted or reported. All doors that were opened appeared to operate as expected with no sticking or gaps noted.
- Door replacement is an owner responsibility while maintenance, and painting, is the association's responsibility.
- Similar to windows and other limited common elements that are the responsibility of the owners, associations have coordinated their replacement to maintain uniformity and provide for best possible cost estimates.

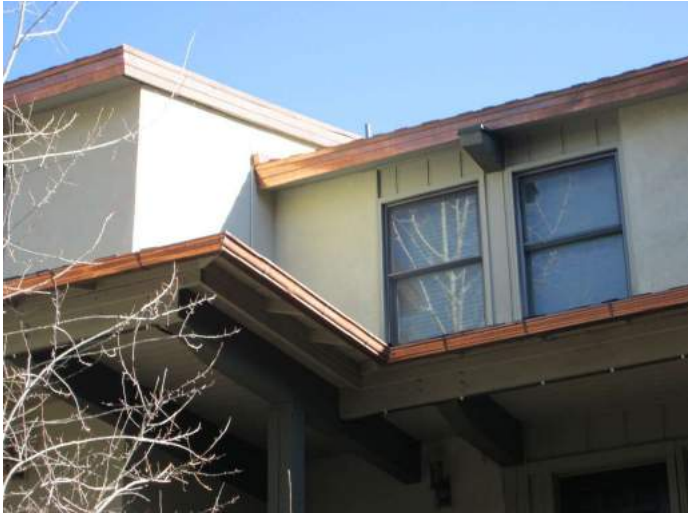
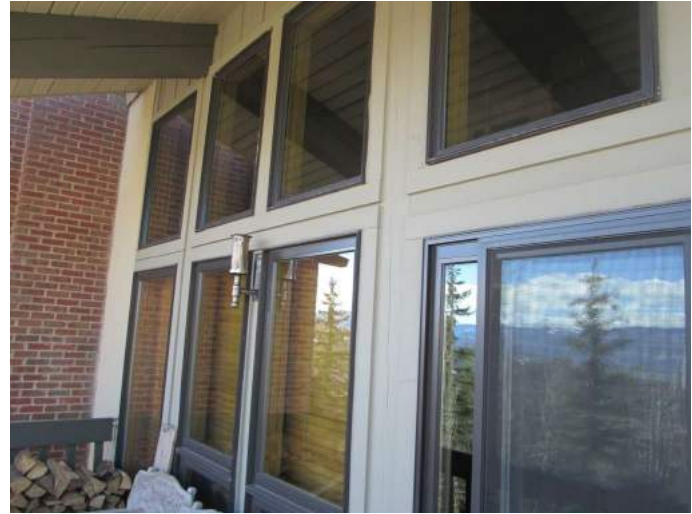
Comp #: 506 Unit Windows - Replace

- The windows appeared to be in fair condition at time of observation. Windows with southern exposures and those on the upper level with less shielding from exposure were beginning to show signs of advanced deterioration.
- As windows are an owner's responsibility, we do not recommend funding for their replacement.
- Some associations, at the benefit and request of their membership, will coordinate property wide window replacement for better cost estimates and to ensure a uniform appearance throughout the property.

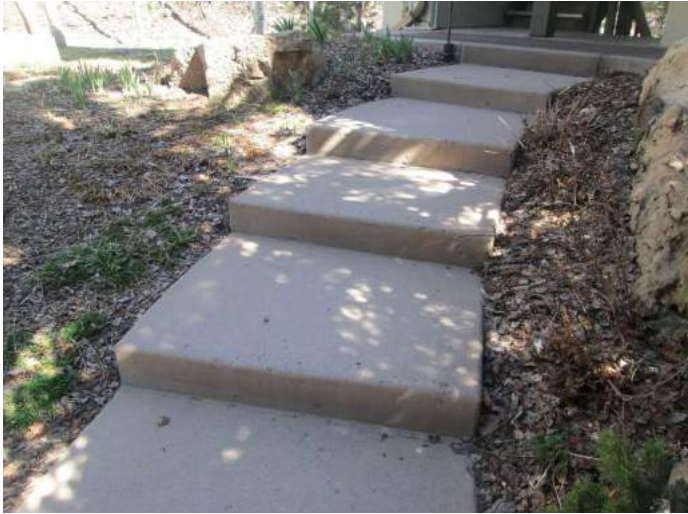
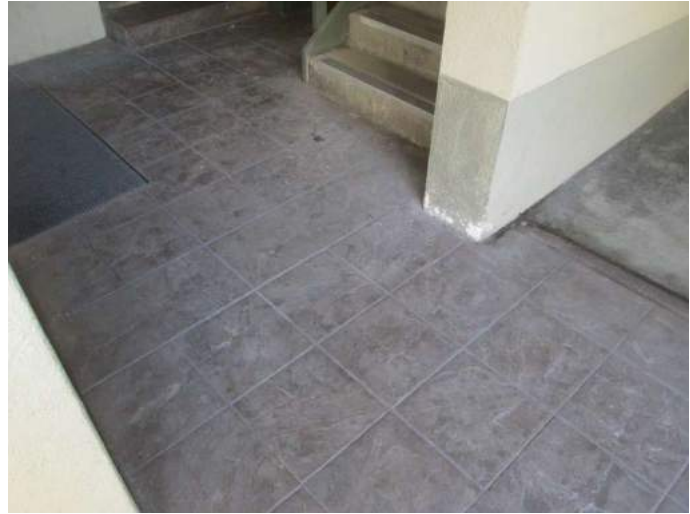
Comp #: 601 Concrete Walks - Repair

- Conditions of walk concrete varied throughout the property from good to fair, during observation.
- As exposures and traffic varies on the walk concrete, and widespread failure isn't anticipated, we recommend funding for replacement of 20% of the concrete (approx. 530 GSF) every 6 years.
- Providing this allowance, at a higher rate for colored and/or stamped concrete, will allow the association to repair/replace failing concrete on a regular basis while allowing for complete replacement every 30 years.+

Allowance to repair 15% of area every 6 years

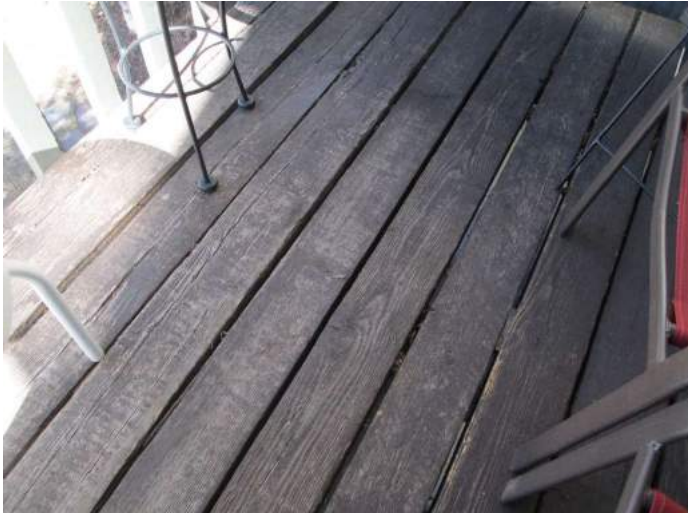
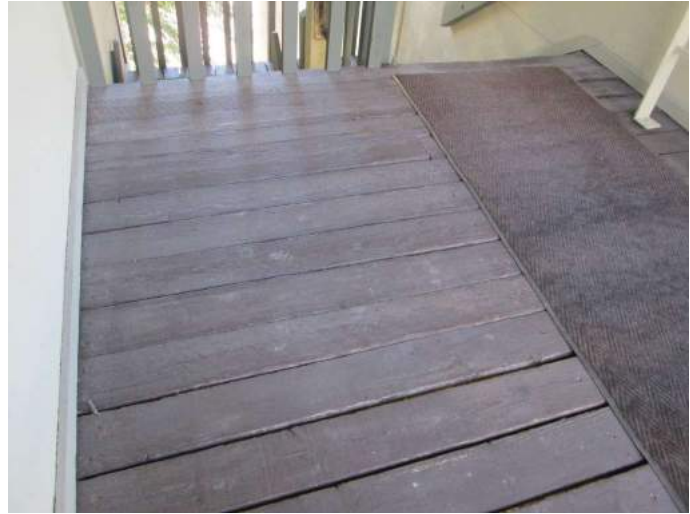
Comp #: 607 Wood Decking - Repair/Replace

- The decking conditions varied, throughout the property, from good to fair throughout the property with only a few areas showing advanced deterioration from exposure, i.e. cracking, warping and rotting.
- As exposure varies throughout the property, we recommend that funding be provided to replace 20% of the decking and railings (approx. 1,025 GSF and 360 LF respectively) every 10 years.
- A capital improvement will be necessary if supports are added for composite decking and new railings.

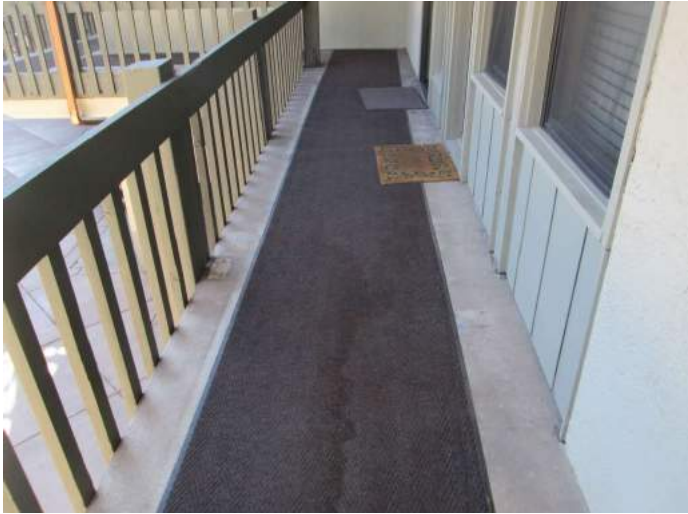
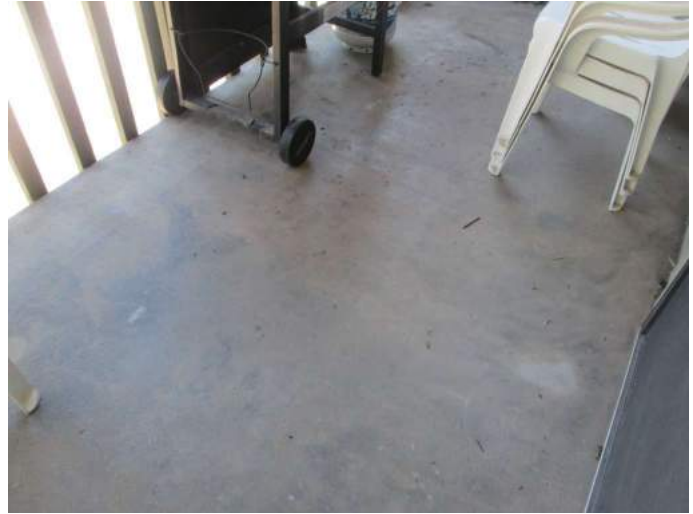
Comp #: 608 Concrete Deck w/ Liner - Repair/Replace

- The concrete decks observed appeared to be in good to fair condition at time of observation with no cracking or spalling noted. Please note that not all decks were observed due to access to private property.
- Due to the semi-protected nature of these decks/walkways, it is unlikely that widespread failure will occur. We recommend that an allowance be provided to replace 33% of the decking (approx. 460 GSF) every 12 years.
- Care should be taken to not chip the surface when shoveling or removing ice.

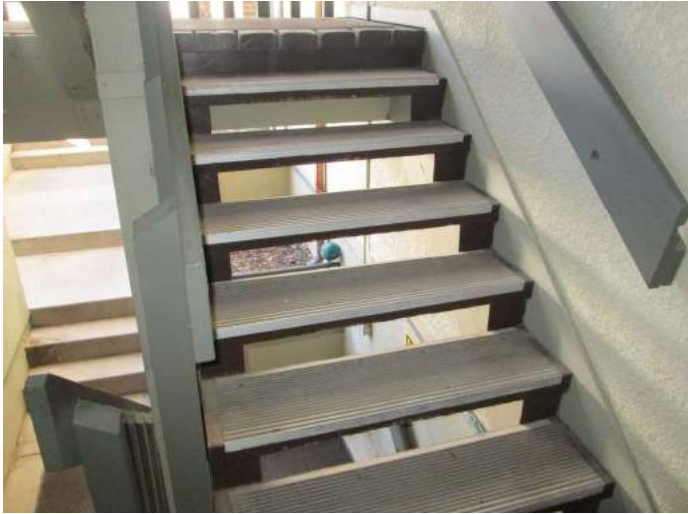
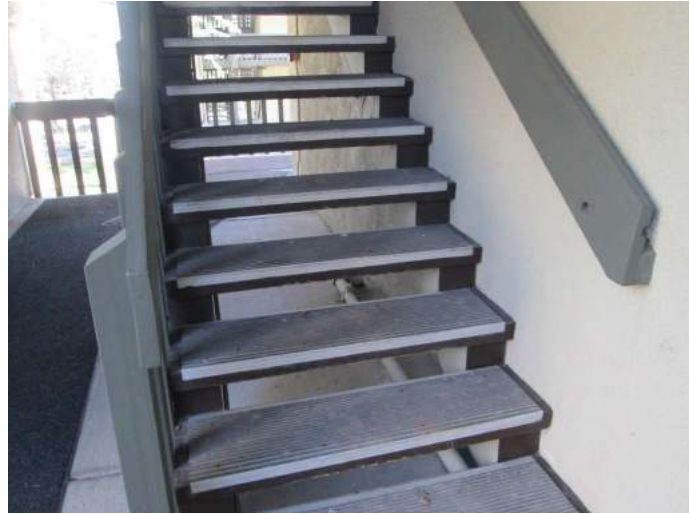
Comp #: 610 Wood Stair Treads - Partial Replacement

- Generally, the wood stair treads appeared to be in good to fair condition with treads on lower levels, and with higher exposures, showing more deterioration. No stairs showing advanced deterioration were noted.
- As widespread failure is unlikely, we recommend an allowance funding method be used to replace 15% (approx. 21 treads) every 5 years. This will allow for the replacement of stairs with higher exposure and/or traffic while allowing for replacement of all treads every 35 years.

**Best Cost:** \$2,000  
Allowance to replace 15% every 5 years

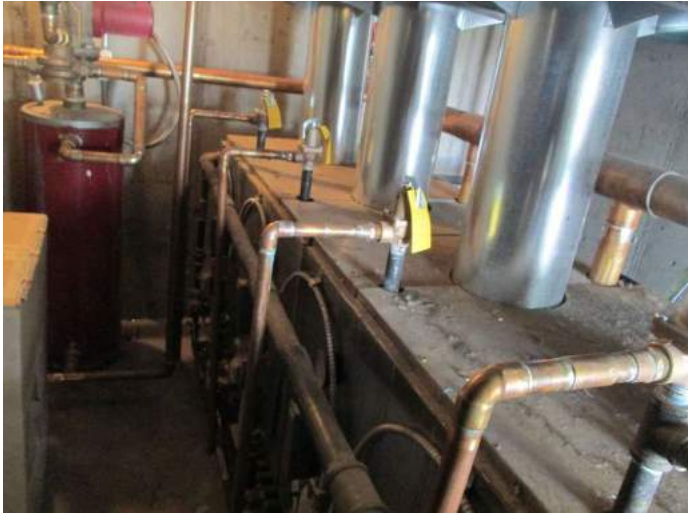
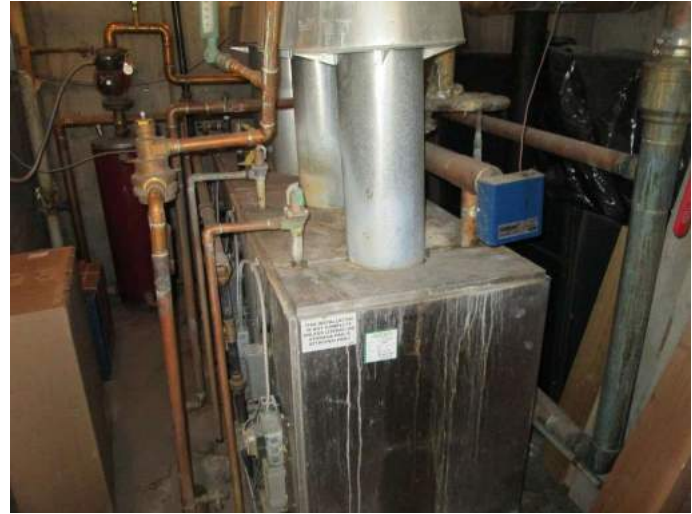
Comp #: 701 Heating Boilers - Rebuild

- At time of observation, the boilers, in general, appeared to be in fair condition with their age showing.
- With regular annual maintenance on these boilers to ensure the longest possible useful life, it is recommended that funding be provided to rebuild the major components when they have reached their half life.
- Rebuilding these boilers will prolong their useful life, but trouble finding replacement parts, irreparable failure of the heat exchangers, and significant decreases in efficiency will necessitate replacement.

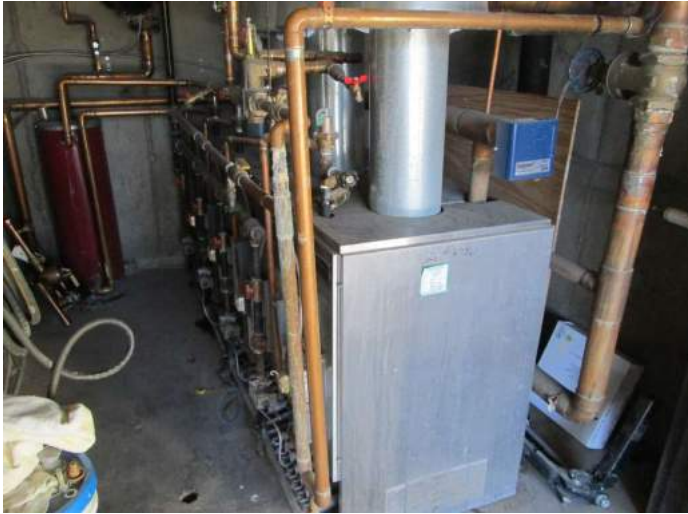
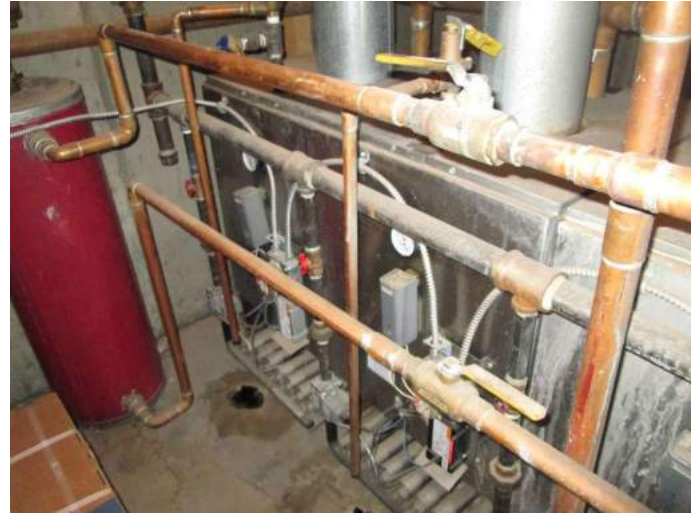
Comp #: 702 Heating Boilers - Replace

- These boilers, generally, appeared to be in fair condition with corrosion and prior leaks noted during observation.
- It is recommended that funding be provided to replace these boilers, on average, every 30 years as replacement parts become difficult to find, efficiencies dramatically decrease and irreparable failures begin to occur.
- The funding provided for the rebuilding at half of their useful life should be combined with this funding. As such, the total cost for replacement of each boiler is estimated to be between \$93,000 and \$105,000.

\$80,000/boiler; stimate to replace boilers

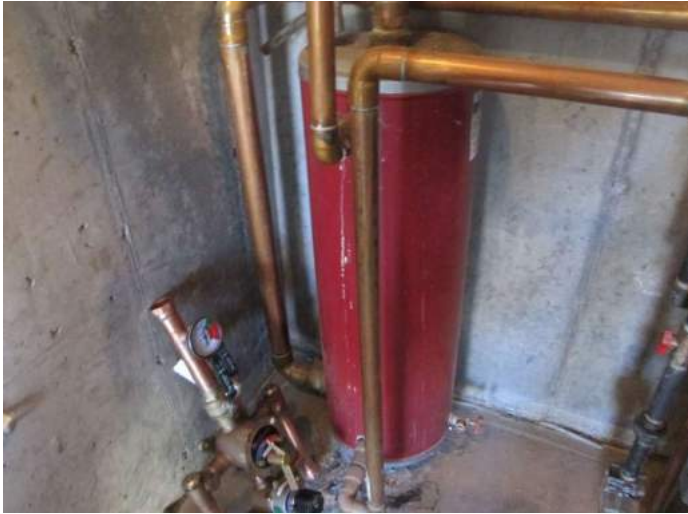
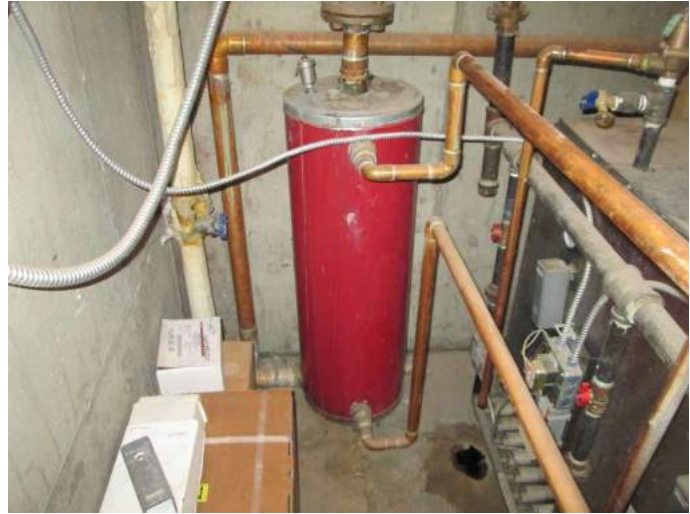
Comp #: 703 Water Heaters - Replace

- The heaters appeared to be in fair condition, during observation, with no apparent signs of advanced deterioration.
- Heaters, of this design, with reported demands, typically have an average useful life of approximately 15 years before failures begin to occur. We recommend that they are replaced prior to failure to avoid higher costs.
- Regular annual maintenance, and care to ensure high water quality, are recommended to ensure the longest possible useful life.

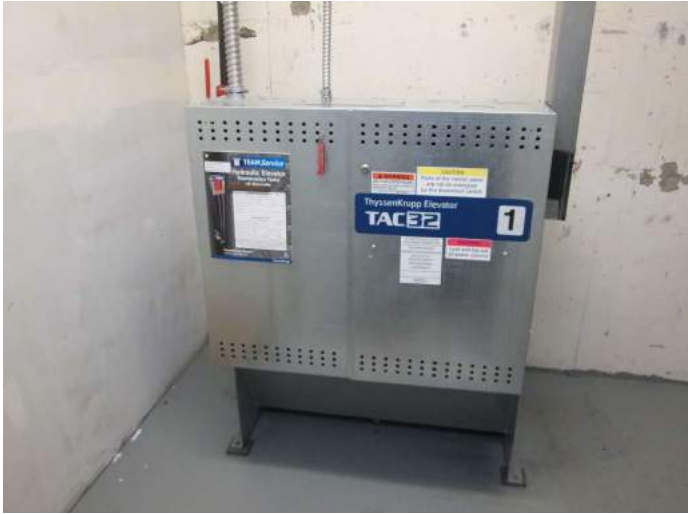
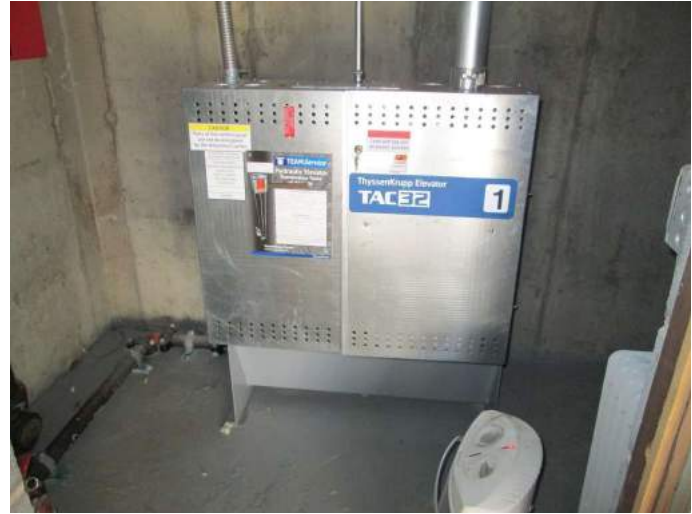
Comp #: 707 Elevators - Rebuild/Upgrade

- At time of observation, the elevator equipment appeared to be in good condition with no unusual conditions noted.
- These controls typically last, on average, approximately 25 years before obsolescence occurs. Typically, this occurs with irreparable damage and/or when repair parts become increasingly difficult to find.
- We recommend regular annual maintenance to ensure the longest possible useful life of this asset. Please note that this pricing doesn't include the replacement of the jack.

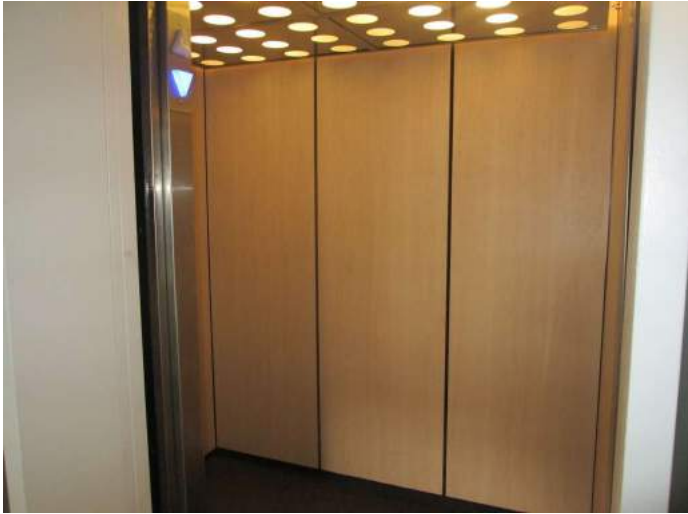
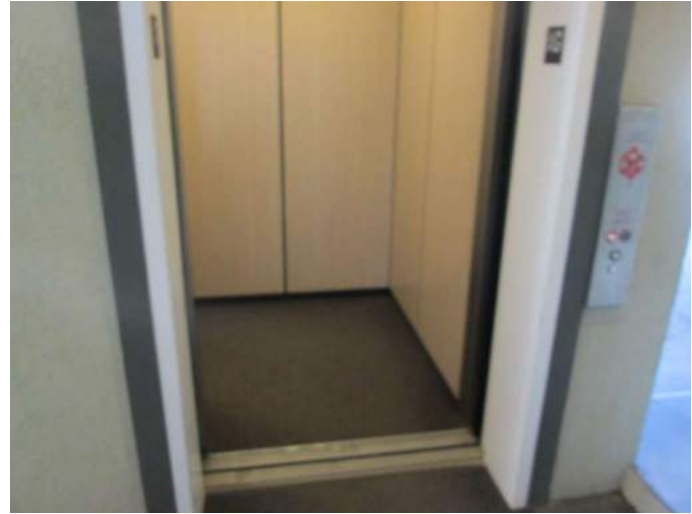
Comp #: 709 Elevator Cab - Remodel

- The elevator cabs appeared to be in good to fair condition at time of observation.
- It is recommended that funding is provided to upgrade the cab interiors approximately every 20 years to conform with current design trends and provide a first class arrival experience.
- The cabs went through minor renovations in 2013, when the systems were upgraded, with new carpeting, control panels, and lighting. Cost estimates and remaining useful have been adjusted to take this into account.

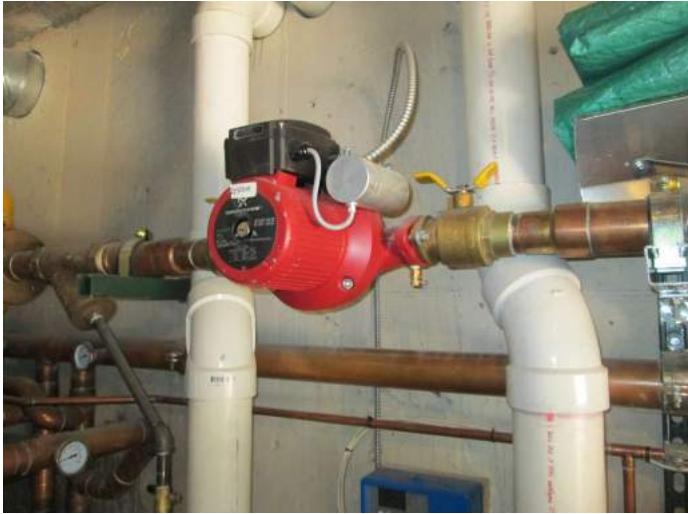
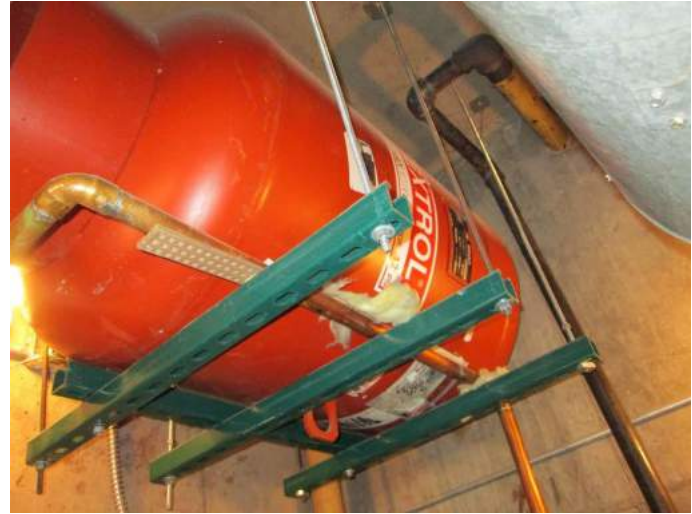
Comp #: 725 Misc. Mechanical Equipment - Replace

- The miscellaneous equipment associated with the boilers, in general, appeared to be in good to fair condition.
- As these components have varying useful lives and costs, we recommend that an allowance be provided to replace failing components every 4 years. This will allow for complete replacement of all assets every 20 years.
- It is recommended that these systems are inspected annually, as part of a regular maintenance program, with needed repairs funded with operating funds. All pumps were replaced in 2011 with snowmelt system added in 2012.

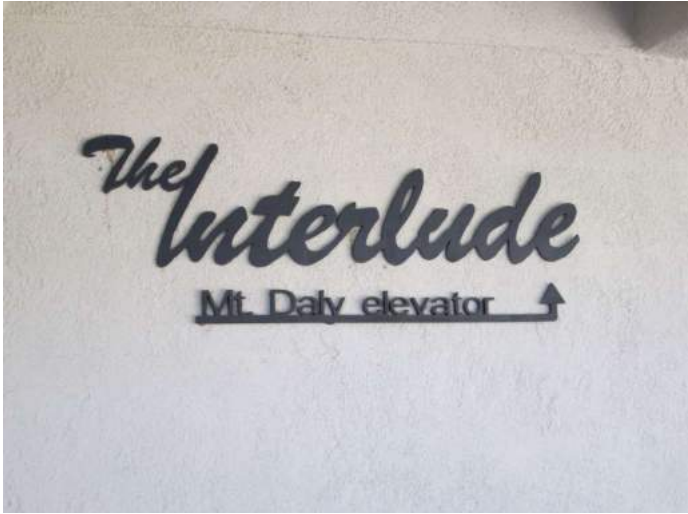
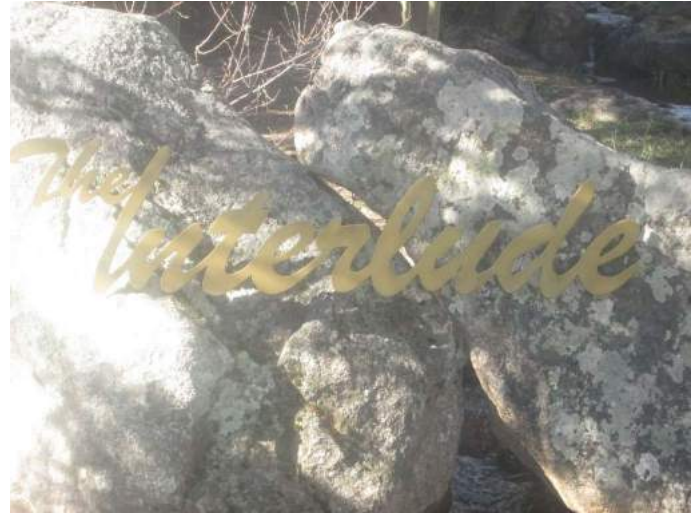
Comp #: 801 Building/Property Signage - Replace

- The signage appeared to be in good condition, with no accelerated deterioration noted, during observation.
- Though the signs are custom fabricated solid steel, with an extended useful life, we recommend funding be provided to replace them, on average, every 20 years to conform with current design trends.

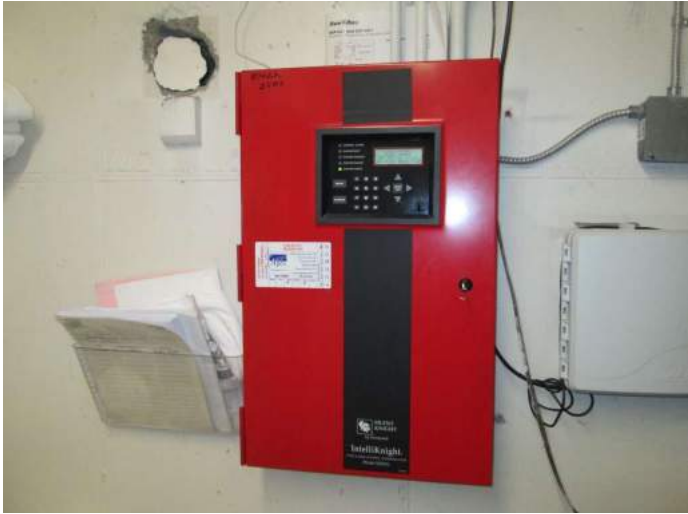
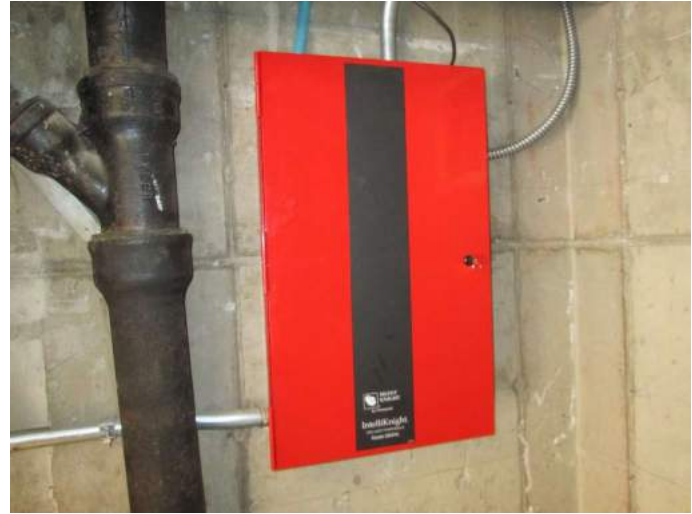
Comp #: 901 Fire Protection System - Replace

- The panels appeared to be in good condition at time of observation with no issues reported.
- It is not likely that widespread failure of the system or its components will occur. Outside of the panels, which have a relatively high cost, equipment should be replaced, as needed, with operating funds.
- It is recommended that funding be provided to replace all panels, and related equipment, approximately every 25 years as repair components become hard to find and to bring the system up to current code.
