**Interlude Condominiums**  
**70 Gallun Lane**  
**Snowmass Village, CO 81615**

**Level 2, Premium Reserve Analysis**

**Report Period – 01/01/15 – 12/31/15**

**Date of Property Observation - April 29, 2015**  
**Project Manager - Eric Vogt, CMCA, AMS**  
**Main Contact Person - Ms. Jami Downs, Community Manager**  
**Report was prepared on - Thursday, July 02, 2015**

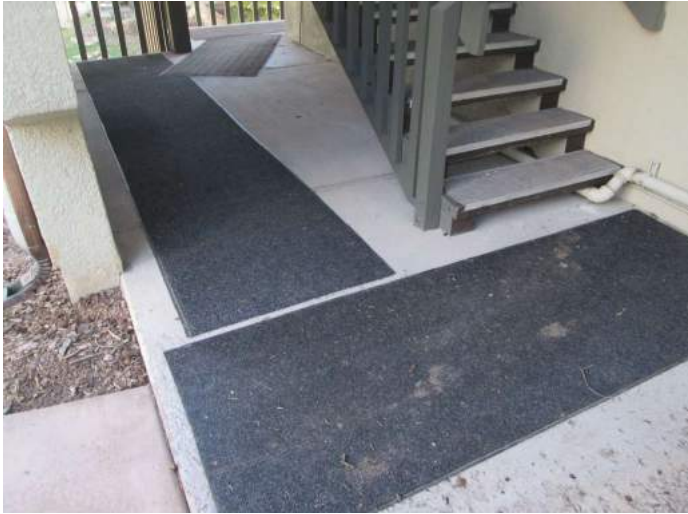
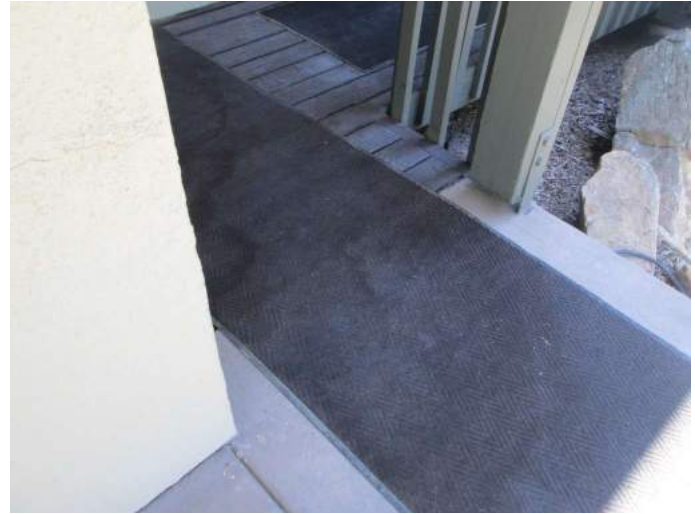
Comp #: 1507 Outdoor Carpet Runners - Replace

- Considering their age (replaced in 2008), the runners are in fair condition with no significant deterioration noted at the edges. Wear patterns and staining are becoming noticeable in the lower floor stairwells that see more traffic.
- To maintain a uniform appearance throughout the property, it is recommended that funding be provided to replace all of the runners at the same time. It is recommend that elevator carpet is replaced at the same time.
- Runners that need to be replaced outside of this replacement cycle should be replaced with operating funds.

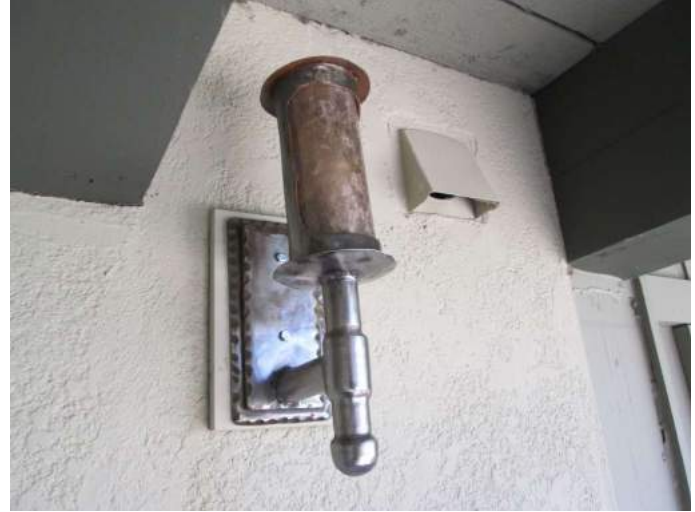
Comp #: 1602 Decorative Exterior Lighting - Replace

- During observations, the decorative lighting appeared to be in like new condition having been replaced in 2014.
- We typically recommend that funding for complete replacement of decorative lighting is provided to conform with current design trends and to maintain a uniform appearance throughout the property.

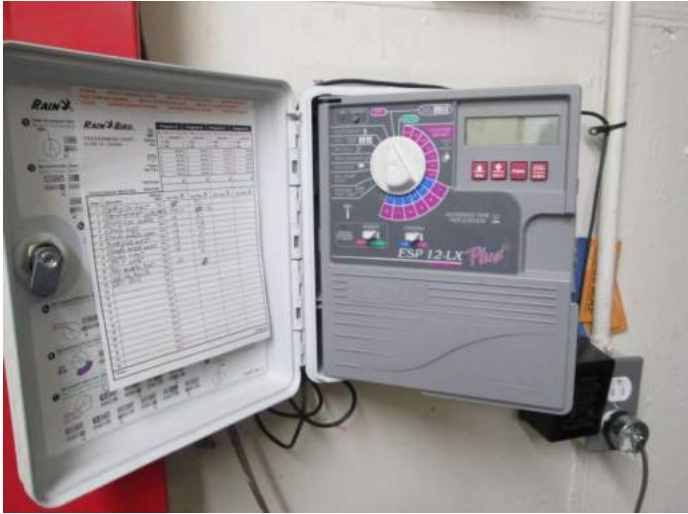
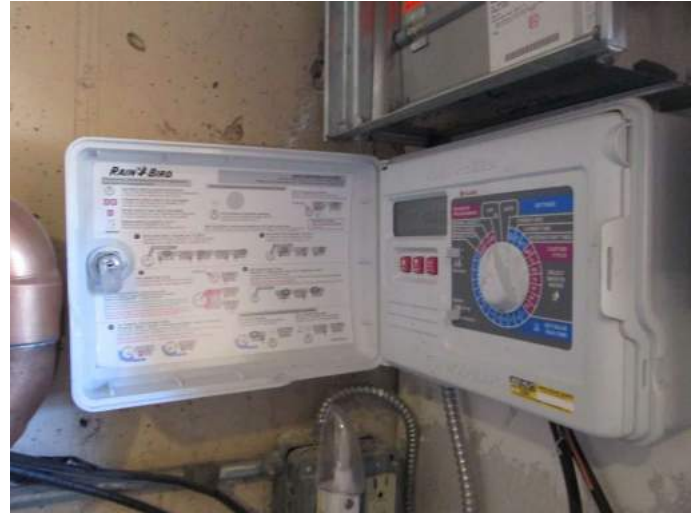
Comp #: 1703 Irrigation Controllers - Replace

- The irrigation controllers appeared to be in good condition, during observation, with no issues reported. The system was not active during observation.
- Funding for the replacement of these controllers is recommended every 10 - 15 years to ensure proper operation.
- The industry is moving towards ET (evapotranspiration) controllers as they significantly reduce water usage and can save the association money over the life of the controller

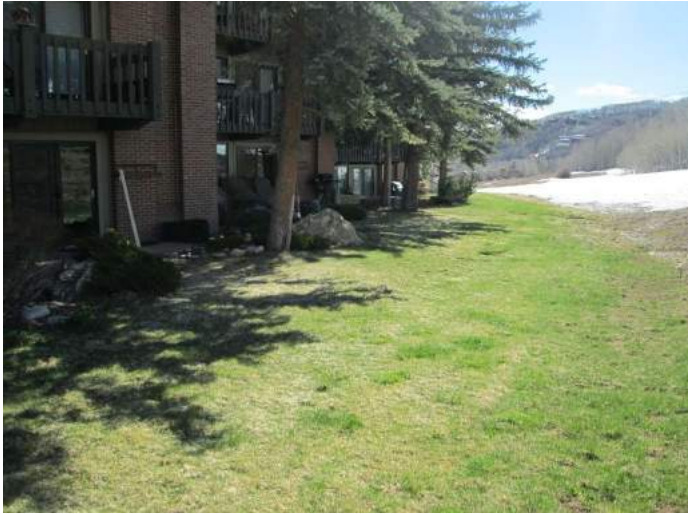
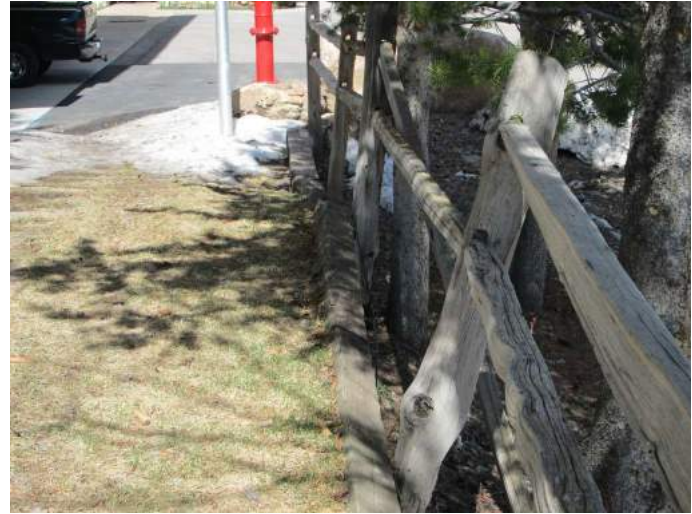
Comp #: 1801 Landscaping - Replenish

- Generally, the landscaping conditions varied throughout the property with most areas well maintained. However, the flagstone walkway, and adjacent retaining wall/fence, are in poor condition and need to immediate attention.
- It is recommended that an allowance be provided to replenish the landscaping throughout the property on a regular basis. This allows for removal of aging vegetation, addition of new vegetation and addressing erosion/grading issues.
- This work should encompass all improvements not related to the annual landscape maintenance contract.

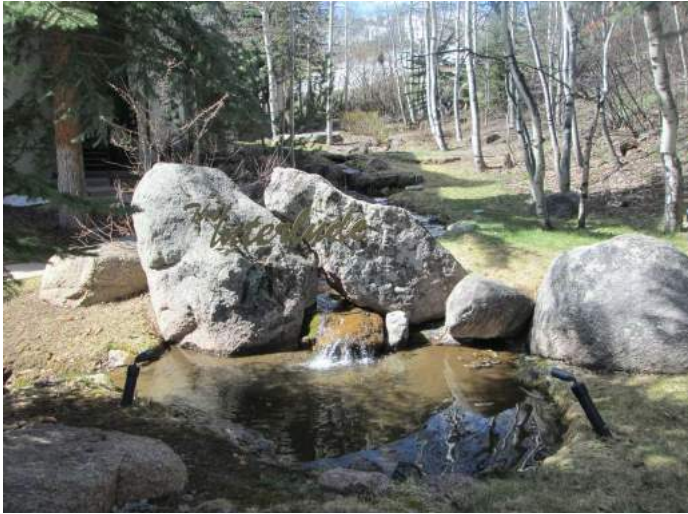
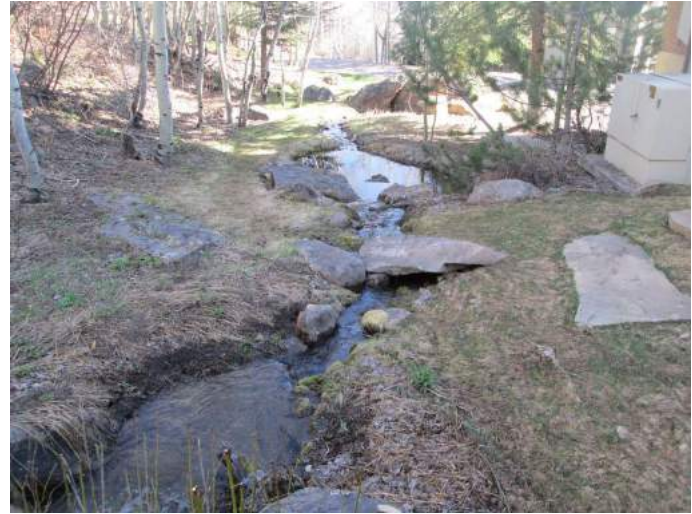
Comp #: 1807 Waterscape Liners - Replace

- The waterscape beds appeared to be in fair condition with the liner exposed in several areas.
- It is assumed that 45 mil EPDM was used to line all ponds and the streams connecting the ponds. Typically, with proper maintenance, these liners last approximately 30 years before they need replacement.
- It is recommended that care is taken to not disturb the beds and that any exposed liner is covered to protect it from accelerated deterioration due to UV exposure.

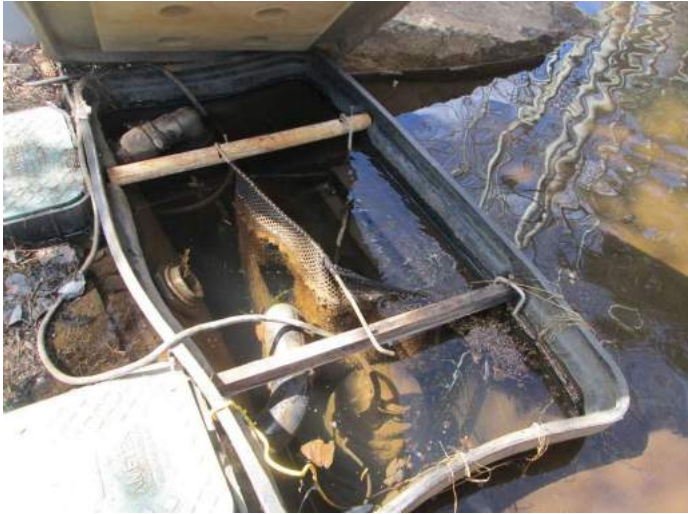
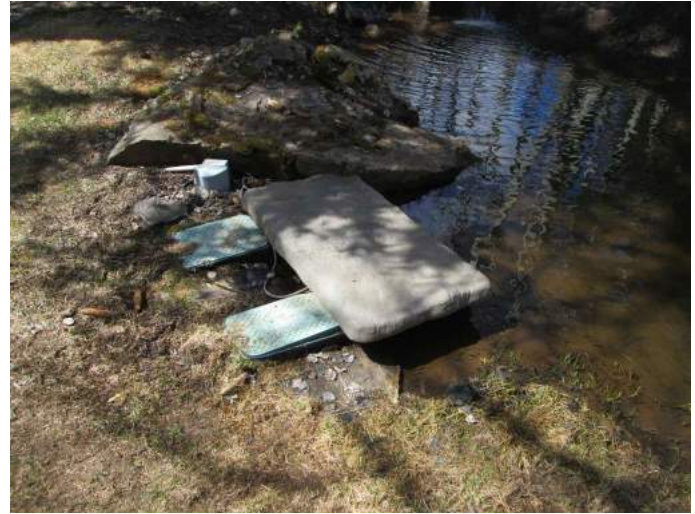
Comp #: 1808 Waterscape Equipment - Replace

- The two pumps appeared to be functioning properly during observation.
- Due to the relatively low cost for replacement, we recommend that failing pumps are replaced, as needed, with operating funds.
- The pump enclosure should be cleaned twice a year and care should be taken to ensure inlets are free of debris.

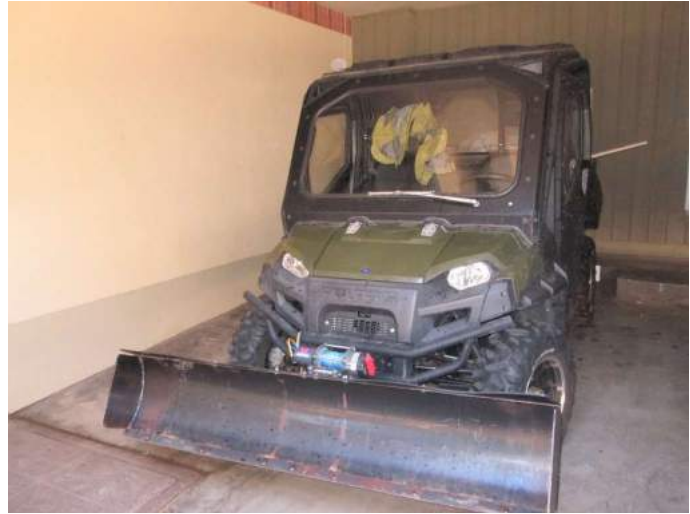
Comp #: 1901 Utility Vehicle - Replace

- Though the utility vehicle is 6 years old, it appears to be in good to fair condition with no unexpected damage noted, or reported, during observation. It should be noted that the check engine light was on during observation.
- Funding for complete replacement of the vehicle, and it's attachments, is recommended approximately every 12 years based on reduced usage patterns with the new snowmelt system.
- Regular annual maintenance should be performed to ensure the longest possible useful life.
