**Interlude Condominiums**  
**70 Gallun Lane**  
**Snowmass Village, CO 81615**

**Level 2, Premium Reserve Analysis**

**Report Period – 01/01/15 – 12/31/15**

**Date of Property Observation - April 29, 2015**  
**Project Manager - Eric Vogt, CMCA, AMS**  
**Main Contact Person - Ms. Jami Downs, Community Manager**  
**Report was prepared on - Thursday, July 02, 2015**

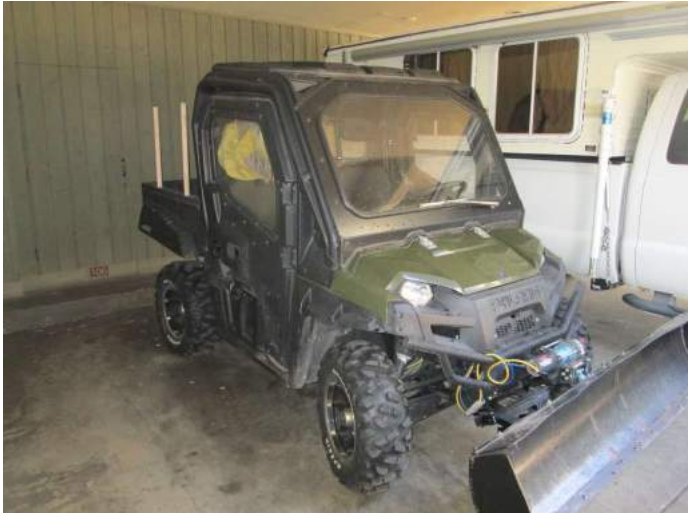
Comp #: 1901 Utility Vehicle - Replace

- Though the utility vehicle is 6 years old, it appears to be in good to fair condition with no unexpected damage noted, or reported, during observation. It should be noted that the check engine light was on during observation.
- Funding for complete replacement of the vehicle, and it's attachments, is recommended approximately every 12 years based on reduced usage patterns with the new snowmelt system.
- Regular annual maintenance should be performed to ensure the longest possible useful life.
